VOUGHT CORP DALLAS TX  
HYDRAULIC SYSTEM SEAL DEVELOPMENT. (U)

USAAVRADCOM-TR-81-D-17

## HYDRAULIC SYSTEM SEAL DEVELOPMENT

Final Report for Period September 1978 - October 1980

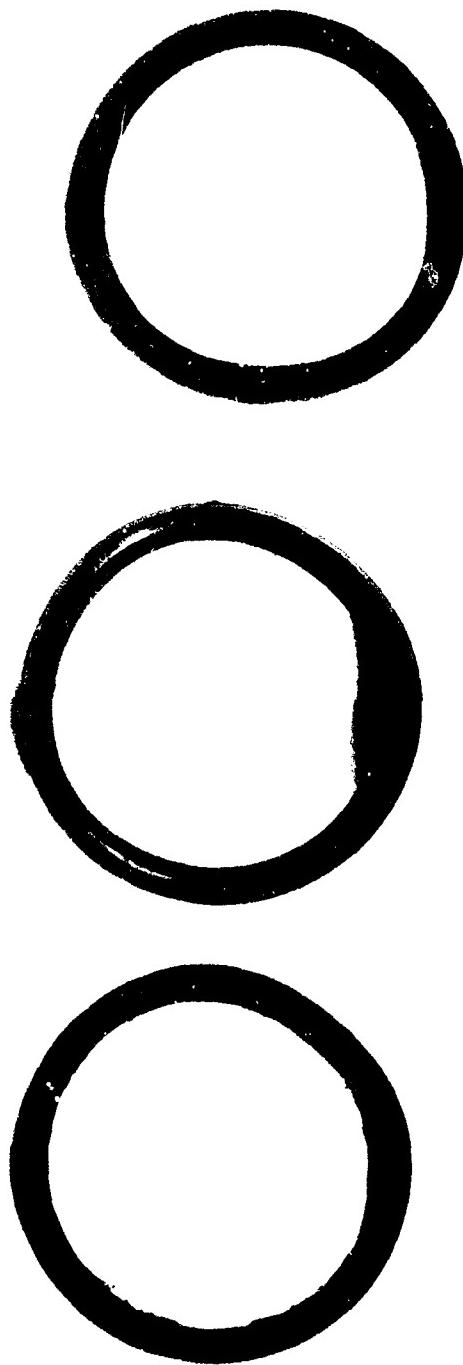
PLUS SEAL (ACT. NO. 3, LUG END, GROOVE C)

ACTUATOR NO.	3
ROD END	
LUG END	X
TOTAL STAGES	1
TOTAL ROD LEAKAGE 1.13 cc (17 Drops)

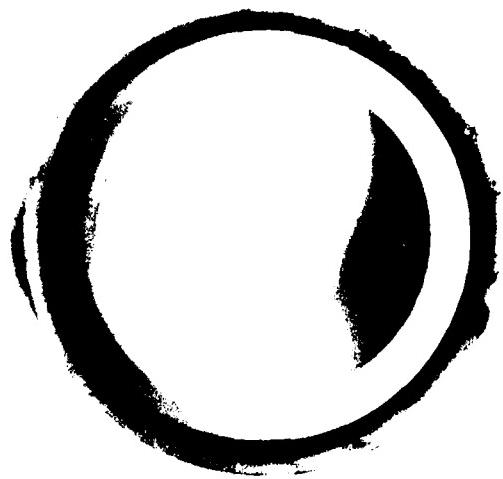
WIPER/SCRAPER (ACT. NO. 3, LUG END, GROOVE D)

The scraper was broken during removal.

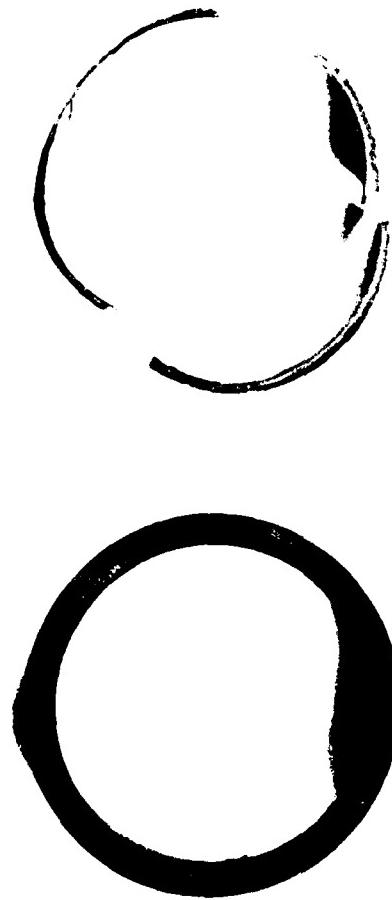
ENERCAP (ACT. NO. 3, ROD END, GROOVE B)

ACTUATOR NO.	3
ROD END	X
LUG END	
TOTAL STAGES	2
TOTAL ROD LEAKAGE 255.4 cc - Failed at 16,248,240 cycles (10,686,390 cycles of rotor feedback)

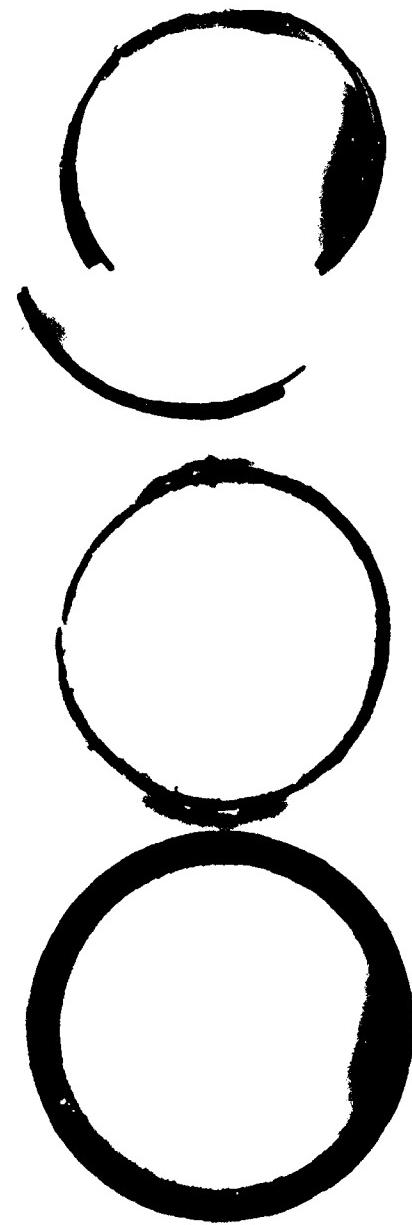
ENERCAP (ACT. NO. 3, ROD END, GROOVE C)

TOTAL ROD LEAKAGE 255.4 cc - Seal failed at 16,248,240 cycles. This  
scraper survived the entire test. (10,686,390 cycles of rotor feedback)
